# CASE STUDY

## DEVELOPING A WEAR-RESISTANT COATING FOR DRILLING COMPONENTS

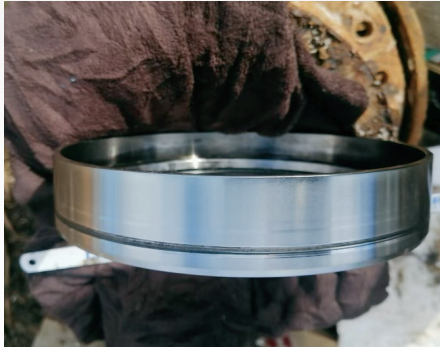
Seal bushing - TEKAD 1000 coating - DED process

The solution sought by the team at TEKAD Industries Inc. involved the replacement of the chromium layer with a TEKAD®1000 coating. This material is characterized by high matrix hardness and, among other things, a significantly high chromium micro-carbides content (70 HRC). The deposit was achieved through Directed Energy Deposition (DED) technology. This process allowed for the use of a short, 1026 steel segment, along with a thin layer of coating, to increase wear and corrosion resistance without compromising the toughness of the base material. The approach helped reduce costs and created a part with outstanding mechanical properties, none of which could have been achieved through traditional processes. After applying the coating, the part was ground and polished to a surface roughness of Ra 16 µm; an ideal surface finish for joints.

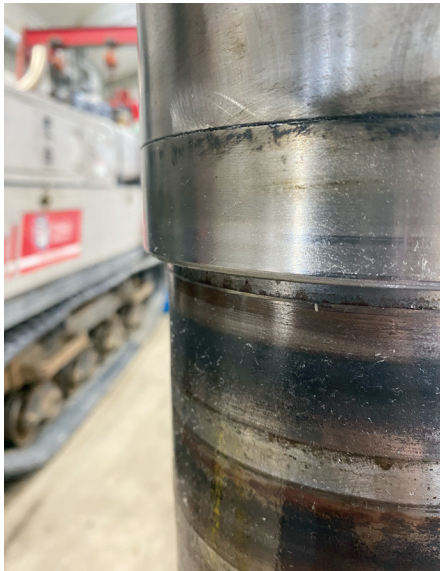
Seal bushing (after tests)

### BENEFITS/RESULTS
