# CASE STUDY

## TI-6AL-4V VALVE BONNET REPAIR

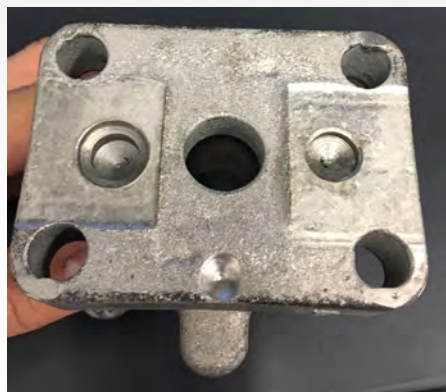
Valve bonnet with defect.

These issues required a repair technology that produces very low induced heat. The solution involved Directed Energy Deposition (DED) or, more specifically, the Optomec's LENS process. Here, Ti-6Al-4V powder was projected into the laser beam in an inert argon atmosphere. Six hundred- $\mu\text{m}$ -wide and 450- $\mu\text{m}$ -thick passes with low laser power helped minimized the thermal stress, distortion and risk of cracking. Parts repaired in this way can be returned to their regular post-treatment process, thus minimizing external additive manufacturing costs.

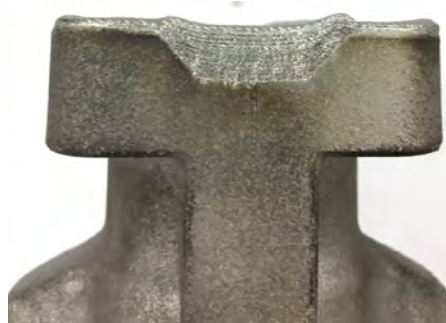
Valve bonnet repaired
